Manhole Inspection Summary

Manhole # S23GG_042MH

Insp Date: **10/9/07 9:08 AM**

Location Address: **1520 CAREY ST**

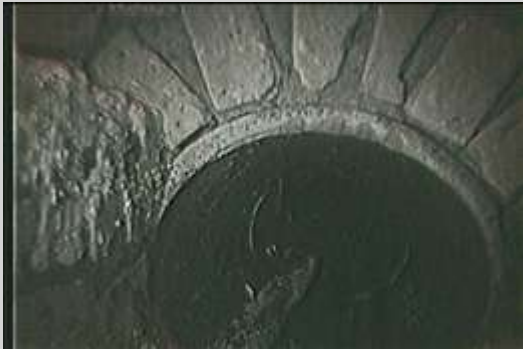
10 in. Circular Gravity Sewer Pipe Out @ 12 O'Clock

Deposits: ☒ None ☐ Mud ☐ Sludge ☐ Debris ☐ Grease

Infiltration: **None** Pipe Seal Cond: **Unknown**

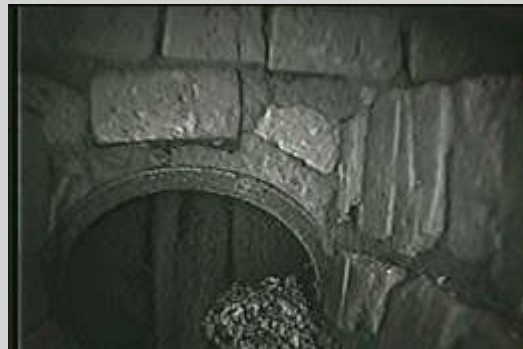
Drop In @ 3 O'Clock

Infiltration: **Evidence** Pipe Seal Cond: **Unknown**

Drop: **Outside** Rod and Bar

Drop Condition: **Open**

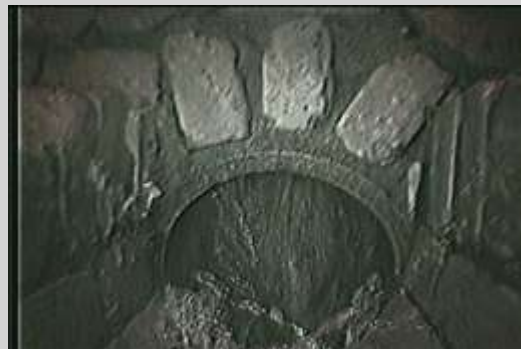
Drop In @ 6 O'Clock

Infiltration: **Evidence**

Drop Condition: **Open**
